TILLAMOOK COUNTY REWITNESS #1 1111 #1

SEC. 35/36
COR. 2 11 T 1 & 2 N R 6 W., WM.

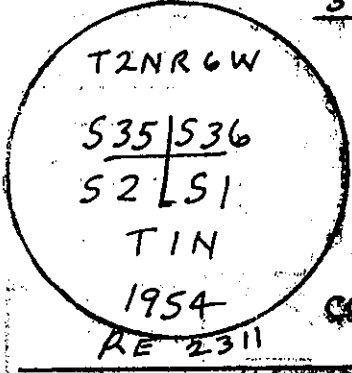
CONDITION GOOD FOUND 1 1/2" IRON PIPE WITH 3" O.S.B.F BRASS CAP

* FD NOW 20" FIR FACE OVERGROWN	6" FIR	S. 14° E. 38'	BOOK 1 PAGE 154
* FD NOW 22" FIR FACE OVERGROWN	6" FIR	S. 43° W. 46'	BOOK 1 PAGE 154
FD. SCRIBING VISIBLE	26" FIR STUMP	N. 15° W. 14'	BOOK 1 PAGE 154
* FD NOW 23" FIR FACE OVERGROWN	7" FIR	N. 53° E. 153'	BOOK 1 PAGE 154
FD. ROTTEN REMAINS	8" CEDAR	N. 31° E. 9 LKS.	G.L.O. Pg. 12
FD. ROTTEN REMAINS	8" CEDAR	S. 18° E. 25 LKS.	G.L.O. Pg. 12
FD. ROOT HOLE	6" CEDAR	N. 52° W. 14 LKS.	G.L.O. Pg. 12
FD. UP ROOT	15" CEDAR	S. 30° W. 43 LKS.	G.L.O. Pg. 12

COMMENTS: THIS CORNER IS LOCATED ± 500' NORTH OF THE POWER LINES & ± 500' WEST OF THE SAME POWER LINES.

I SET 10" CONCRETE CYLINDER AROUND FOUND O.S.B.F. 1 1/2" IRON PIPE WITH 3" BRASS CAP. BK. 1 Pg. 154
* 84" Flat Section NORTH 15 FEET
