TILLAMOOK COUNTY REWITNESS

22+23_T IN R 10 W., WM.

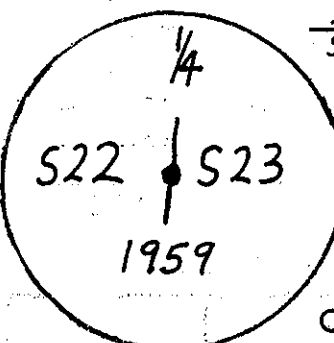
CONDITION GOOD

FOUND: OSBF BRASS DISC DN 1 1/2" IP BK 1 Pg 369

NOT FOUND	16" SPRUCE	N. 43° W. 48 LKS	GLO Pg. 6
FD. ROTTEN STUB NO SCRIBING	48" HEMLOCK	S. 41° E. 9 LKS	GLO Pg. 6
FD. ROTTEN STUB	30" HEMLOCK	S. 51° W. 49 LKS	BK 10 Pg. 18
NOT FD. (IN SLIDE AREA)	31" HEMLOCK	N. 31 1/2° W. 29 3/4 FT	BK 3 Pg 369
FOUND FACE GROWN OVER RESCRIBED 1/4 S23 BT CS NOV 36	18" HEMLOCK	N. 46° E. 37 FT	BK 3 Pg 369
		N 45 1/2° E 36 3/4 FT

COMMENTS: THIS CORNER IS LOCATED ON A STEEP HILLSIDE ON THE NLY EDGE OF A CLEARCUT.

1 SET CEMENT AROUND FOUND OSBF BRASS DISC AND 1 1/2"

IRON PIPE CS REWITNESS BK 1 Pg. 369

SET A *60" Hat Section SOUTH 15 FEET

*20" HEMLOCK	N. 11° E. 21 1/2'	1/4 S CS BT
36" HEMLOCK ^{OLD FOREST} BT	N 45 1/2° E 36 3/4'	1/4 S23 BT CS
DISTANCES TO BRASS WASHER WITH NAIL IN FACE
