TILLAMOOK CO. REWITNESS #137
SEC. 26 25
SECTION COR. 35 36 T 3N R 10 W., WM.

HISTORICAL: GLO T3NR10W Pg 9

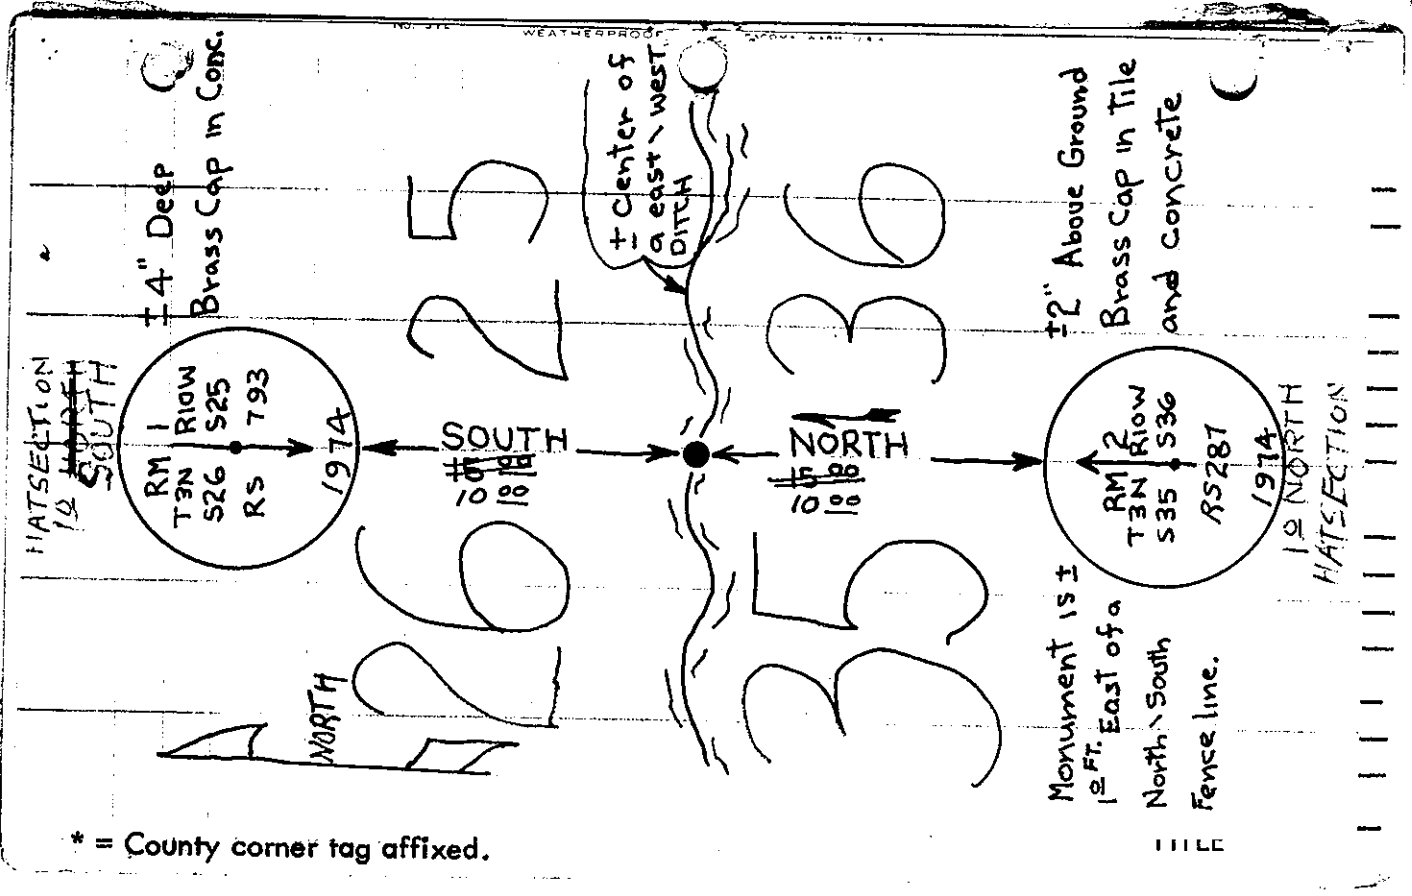
THIS CORNER WAS A ±1" IRON PIPE UNTIL
 ± SUMMER OF 1969 AT WHICH TIME STAN
 JUD HAD A EAST-WEST DITCHLINE DUG.
 STAN JUD REMEMBERS REMOVING THE PIPE.
 HE FAILED TO REPLACE THE SECTION
 CORNER BECAUSE HE FELT THAT HE COULD
 NOT REPLACE IT ACCURATELY.

USING FIELD TIES BY COUNTY
 SURVEYOR - W.E. ANDERSON AND COUNTY
 SURVEYOR - J.L. CARLICH, THE SECTION
 CORNER WAS RE-ESTABLISHED
 W.E.A. - SURVEY - C.S. MAP A-813 & field
 M. ELLSWORTH
 J.L.C. - SURVEY - C.S. MAP A-917 & field
 M. JOHNSTON N. LINE notes

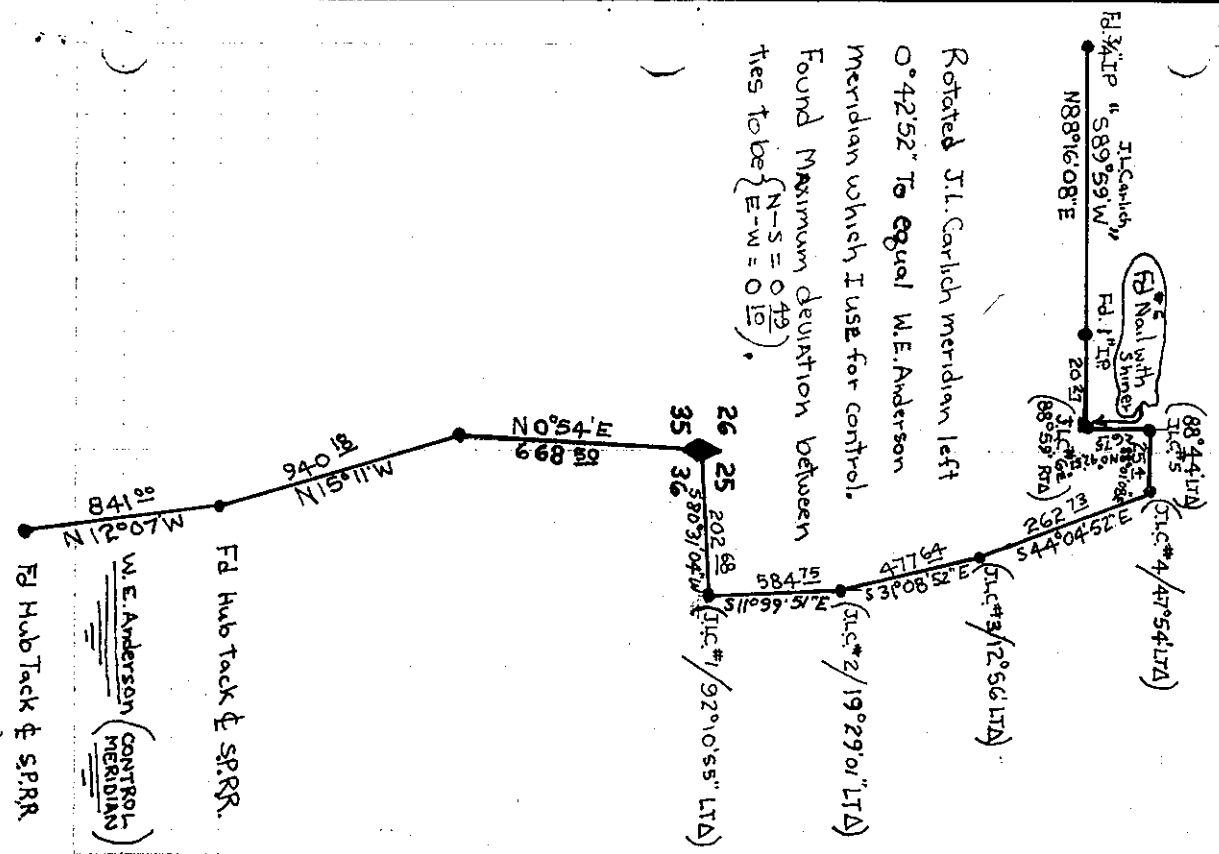
Rotated J.L. Carllich meridian left
 0°42'52" to equal W.E. Anderson
 Meridian which I use for control.
 Found Maximum deviation between
 ties to be { N-S = 0.49
 E-W = 0.10 }.

26 25	= APPROXIMATE POSITION BY C.Z. # 2 X 4 HUB	
35 36	of E-W DITCH & PROJECTION OF N-S FENCE	
	LINE LOCATED SOUTH OF SECTION CORNER	
118 95	119 28 @ 94°16' = 4°16' W 23690	N 157526
	4 252°26'0" - 4	S 81°58'58"E
	2 107°33.6'	
	m 107°33.8'	
C	726'12" LTA	S 9°32'46"E
D		
Found 1/2" Iron Pipe at ± position of 2x2 W.S. set by WEA (CS MAP A-401) Refer to field notes		
FD 1/2" Iron Pipe	N 1120 56	Possible POSITION OF THE NORTHWEST CORNER OF MAP A-401
	W 239 85	
485 08	E D.M. @ 90°07' 0°07'	
	4 184°09.0' + 2	S 13°41'40"E
	2 175°51.2'	
	m 175°51.1'	
C	4°08'54" LTA	S 9°32'46"E
D

A = Found Hub tack & R&R Tracks - See field notes for Harold ELLSWORTH - C.S. MAP A-813 Section 36 T3NR10W

B = Found Hub Tack & R&R Tracks - See field notes for Harold ELLSWORTH - C.S. MAP A-813 Section

C = Spruce limb on north side of E-W Ditch ± 3 feet north of north edge of ditch - ± 2" below surface

D = (#) 6 of survey by St. Carlich - Map A-917 - See field notes - Section 26 T3NR10W - Roofing nail with shiner on fence projection - located in middle of west lane of pavement - ± 2" below existing Black Top

E = FD. 1/2" Iron Pipe ± 8" above ground and ± 15 feet west of end of existing fence in mass of black-berry vines - ± 4" west of old rotting stump Pipe is badly rusted
