TILLAMOOK COUNTY REWITNESS

#319

SEC. 24
COR. 25 T 15 R 10 W., WM.

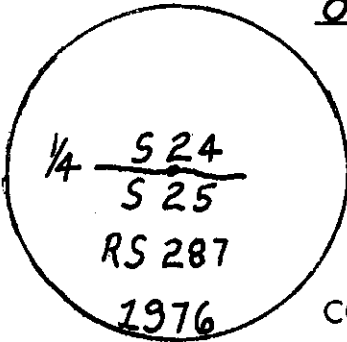
CONDITION BADLY RUSTED FOUND: 1/2" IRON PIPE

BK 4 Pg 84
GONE	28" SPRUCE	N 21° W 9 LKS	GLO Pg 17
GONE	20" SPRUCE	S 5° E 24 LKS	GLO Pg 17
GONE	24" SPRUCE	N 21° W 29 LKS	BK 4 Pg 14
* FD GOOD NOW 36"	20" SPRUCE	S 65° W 343 FT	BK 4 Pg 84
* FD GOOD NOW 24"	12" SPRUCE	S 35° E 632 FT	BK 4 Pg 84

COMMENTS: THIS CORNER IS LOCATED ± 2 1/2' NORTH
OF AN EAST-WEST DITCH LINE AND ± 50' EAST OF HOGUARTEN
Slough.

I SET 2" IRON PIPE WITH 3" BRASS CAP IN 10" TILE & CEMENT IN POSITION
OF FOUND 1/2" IRON PIPE
84" Hat Section SOUTH 12 FEET
