TILLAMOOK COUNTY REWITNESS # 416

SEC. 28 T 25 R 9 W., WM.
 COR. S. E.
 MARCH 1950 A.S.B.F.

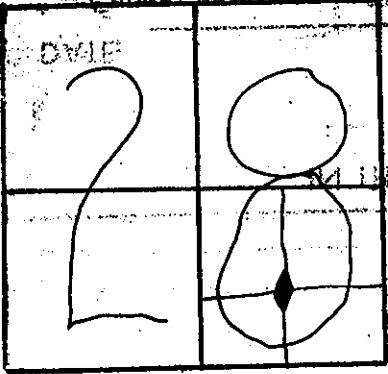
CONDITION Good FOUND: 1 1/2" Iron Pipe

Now 22" spruce Good * 18" Spruce NO°26E 36°	
B.T. CONDITIONS FOUND 6-17-1998 BELOW	
* 22" SPRUCE NO°26'E 36°; FOUND, NOW 34" SPRUCE FACE HEALED POSITION	
* 48" HEMLOCK N59°E 81 1/2. FOUND 74" SPRUCE @ POSITION, FACE HEALED, DO NOT CUT TAG ATTACHED.

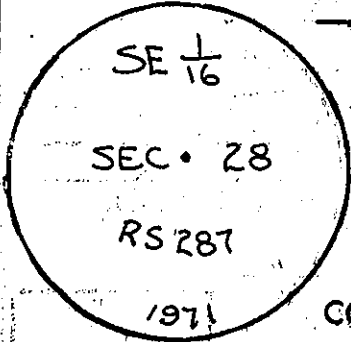
* ±90 " Hat Section		± 15 feet
NEW ACCESSORY:		
48" HEMLOCK * N59°E 81 1/2

COMMENTS: Corner is located on county road that goes to Munson Creeks Falls Park. Corner is on south side of road ± 15 feet from road CENTERLINE AND located part way up the cut-back slope.

1 SET 2" Iron Pipe with Brass Cap in tile & Cement
