TILLAMOOK COUNTY REWITNESS # 609  
 N. 1/16 COR. SEC. 11 T 35 R 10 W., WM.

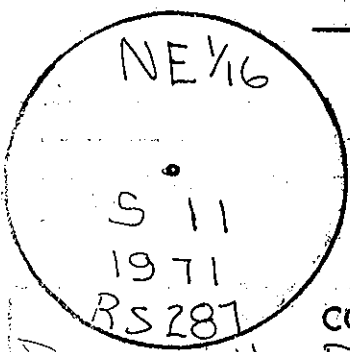
CONDITION	FOUND:	8" SPIKE	Bk	Page
OK	5/8" Iron Rod	North 12.65	5	127
OK	5/8" Iron Rod	South 28.35	5	127
OK	Power Pole	N 81° W 108.40	5	127
Replaced with Hat section	4x4 Post	North 12.0		
RESET: 5/8" IR. "NORTH	12.65" TO NORTH	20.30' DUE TO ROAD WORK		DA 2-24-92

\* 96 " Hat Section NORTH 12.00  
 RESET TO NORTH 20.80 DUE TO ROAD WORK DA 2-24-92

COMMENTS: Removed Spike & Placed Iron Bar with Brass Cap for Corner.
