LAND CORNER RECORD

T. 6S R. 9W No. E-3 Cor. 7 Mer. Will State ORE N. F. SILLSLAW Dist. Heb

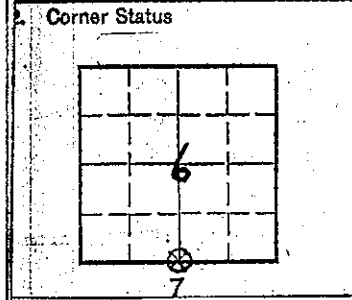
5. Investigation Notes: **#966**
 FOUND 1/2 IN. GALV. PIPE 1 1/2 FT. ABOVE GROUND.
 FOUND 30 IN. HEM. (ORIG) N. 30° W., 18 LKS. LYING UPON THE
 GROUND WITH VISIBLE MKS. 1/4 S 6 BT.
 FOUND 18 IN. FIR STUB (ORIG) S. 45° 30' W., 33 LKS. LYING UPON
 THE GROUND WITH VISIBLE MKS. 1/4 S 7 BT. 1943 - 1959
 LOCATION F.S. POSTERS ARE ON BOTH LOGS.
 THIS CORNER IS LOCATED IN THE CENTER OF A RECENT
 BLOWDOWN. I SCRIBE TWO WITNESS TREES OF WHICH
 ARE LARGE FIR SNAGS THAT I FEEL WILL NOT BE

14. Remarks:
 DESTROYED BY THE FUTURE LOGGING OF THIS BLOW-DOWN.
 CORNER IS ON A 15% EAST SLOPE 100 FEET WEST OF A ROAD.
 New BT°
 54 IN. FIR SNAG, S. 70° E., 17 LKS. MKD. 1/4 S 7 BT.
 53 IN. FIR SNAG, N. 11° E., 114 LKS. MKD. 1/4 S 6 BT.
