TILLAMOOK COUNTY REWITNESS

Range Line COR.

T 1 S R 10/9 W., WM.

SECT. COR. $\frac{127}{1318}$ - F 1 S - R 10 & 9 W., WM.

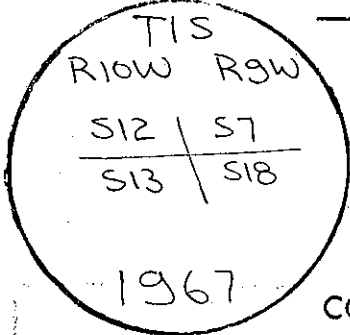
PHOTO#: 280

FOUND: 2" I.P. with 3" O.S.B.F. Brass Cap

Remains	8" N57°E 28 ^{1/4} s		GLO
Gone	4" N41°W 19 ^{1/4} s		GLO
Fd - Rotten - visible scribing	24" S22°W 9 ^{1/4} s		GLO
Gone	16" S46°E 75 ^{1/4} s		GLO
Found - OK *	18" Alder S74° 1/2 W 27 ³ ft		BK 4 Pg 63
Found - O.K. *	12" Spr N22°W 31 ⁵ ft		BK 4 Pg 63
Found - O.K. *	23" Spr N22 1/2°W 31 ⁰ ft		BK 3 Pg 227
COMMENTS: Fd - O.K. *	6" Spr N35 3/4°E 7 ⁰ ft		BK 3 Pg 227
	11" Spr S71 1/4°E 49 ² ft		BK 3 Pg 227
Fd - O.K. *	4x4x50" Post 1 ² ft SW		BK 3 Pg 227

1 SET found O.S.B.F. Cap in 10" Tile with Concrete.

*96 " Hat Section NORTH 15 feet

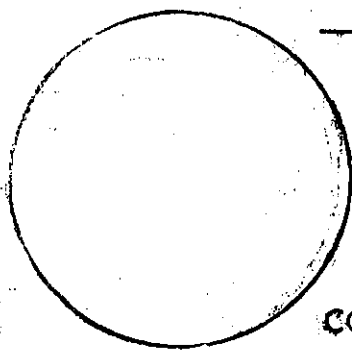
CONDITION GOOD FOUND, O. S. B. F. BRASS CAP IN CONCRETE

SCRIBING BACK EAST VISIBLE	8" HEMLOCK	N. 57° E 28 LKS.	G.L.O.
ROTTEN STUB	24" HEMLOCK	S. 22° W. 9 LKS.	G.L.O.
ROTTEN STUB	18" ALDER	S. 74 1/2° W. 27.3 FT.	BK. 4 Pg. 63
* Now 33" FACE OVERGROWN	12" SPRUCE	N. 22° W. 31.6 FT.	BK. 4 Pg. 63
* Now 23" FACE OVERGROWN	6" SPRUCE	N. 35 3/4° E 7.0 FT.	BK. 3 Pg. 227
* Now 27" FACE OVERGROWN	11" SPRUCE	S. 71 1/4° E 49.2 FT.	BK. 3 Pg. 227

COMMENTS: THIS CORNER IS LOCATED ± 35' EAST OF A GRAVEL ROAD ON JUNO HILL.
