TILLAMOOK COUNTY REWITNESS

22+23_T IN R 10 W., WM.

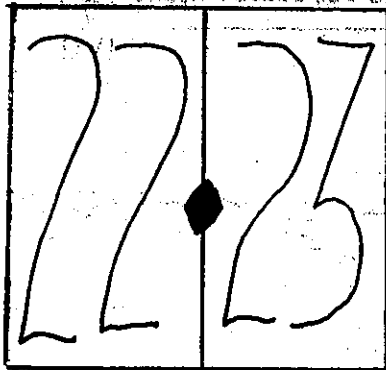
CONDITION GOOD

FOUND: OSBF BRASS DISC DN 1 1/2" IP BK 1 Pg 369

NOT FOUND	16" SPRUCE	N. 43° W. 48 LKS	GLO Pg. 6
FD. ROTTEN STUB NO SCRIBING	48" HEMLOCK	S. 41° E. 9 LKS	GLO Pg. 6
FD. ROTTEN STUB	30" HEMLOCK	S. 51° W. 49 LKS	BK 10 Pg. 18
NOT FD. (IN SLIDE AREA)	31" HEMLOCK	N. 31 1/2° W. 29 3/4 FT	BK 3 Pg 369
FOUND FACE GROWN OVER RESCRIBED 1/4 S23 BT CS NOV 36	18" HEMLOCK	N. 46° E. 37 FT	BK 3 Pg 369
		N 45 1/2° E 36 3/4 FT

1 SET CEMENT AROUND FOUND OSBF BRASS DISC AND 1 1/2"

IRON PIPE CS REWITNESS BK 1 Pg. 369

SET A *60" Hat Section SOUTH 15 FEET

*20" HEMLOCK	N. 11° E. 21 1/2'	1/4 S CS BT
36" HEMLOCK ^{OLD FOREST} BT	N 45 1/2° E 36 3/4'	1/4 S23 BT CS
DISTANCES TO BRASS WASHER WITH NAIL IN FACE
