TILLAMOOK COUNTY REWITNESS

1/4 COR. SEC. 26 T 1 N R 10 W., WM.
35

TILLAMOOK COUNTY REWITNESS TITLE

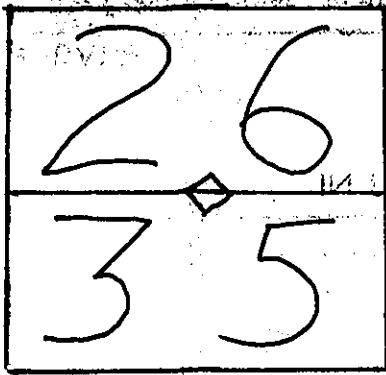
CONDITION GOOD FOUND: P.K. NAIL IN SPRUCE ROOT

FD. ROTTEN STUB	60" HEMLOCK	N. 24° W. 23 LKS	GLO Pg. 4
FD. ROTTEN STUB	24" HEMLOCK	S. 52° W. 23 LKS	GLO Pg. 4
* FD. GOOD NOW 26" ^{FACE} _{GROWN OVER}	24" HEMLOCK	N. 79 1/2° E 32 3/4 FT.	BK. 1 Pg. 371
* FD. GOOD NOW 34" ^{FACE} _{GROWN OVER}	23" HEMLOCK	S. 52 1/2° E 13 3/4 FT.	BK. 1 Pg. 371
FD 4" X 4" X 56" POST	ROTTED OFF; LAYED ALONGSIDE		MONUMENT

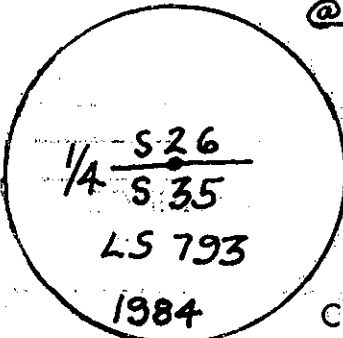
NEW ACCESSORY:

1 SET 1 1/2" IRON PIPE WITH 3" BRASS CAP IN 10" CONCRETE CYLINDER
 @ POSITION OF OSBF P.K. IN X
 * 60" Hat Section 25' NORTH

COMMENTS: THIS CORNER IS LOCATED ± 500'
SW OF THE PP&L POWER LINES AND WLY OF A SMALL
CREEK (IN THE ROOT OF A SPRUCE TREE WHICH WAS SAWED
OUT IN ORDER TO SET THE MONUMENT)
