WINDLO: SEC.
 1/4 COR. 17116 T 35 R 10 W., WM.
 E.17

HISTORICAL: GLO-- W. P. Wright 1882--Pages 38#39
 U. Jackson--1913--F-41-45 MAP F-24-17
 G. J. Paysky--1914-- F-40-58
 W. S. Coates--1920-- B-218 (SHEET No. 7)
 W. E. Anderson--1947-- B-97-- Shows Subdivision of Sec. 17
 W. E. Anderson--1926-- Field Notes-- BK 45 Page 67#68
 BK 48 Page 8 shows G.T.'s to 1/4 cor. Book 5 Page

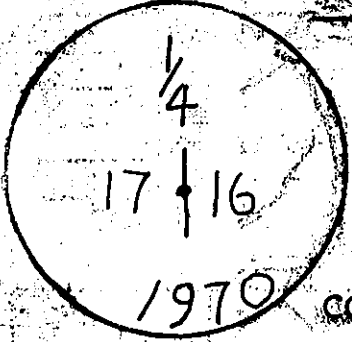
96" Mat Section

Power Pole 121-B.E.	S 72° W 33°	△
* 4" Hemlock	N 79° E 48 ±	1/4 SIG BT CS
Power Pole 120-B.E.	N 12° E 138 ±	△

COMMENTS: CAP IS FLUSH WITH BLACKTOP SURFACING

Fd remains of 24" Hemlock at S 88° E 74 ± feet = Tree has fallen over
