4. Description of Corners: **#636**

PERPETUATION RECORD

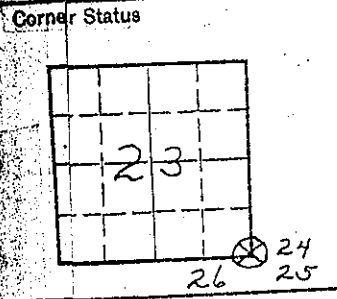
5. Investigation Notes:
 FOUND A BROKEN STUB FOR CORNER IN POOR CONDIT-
 ION UNDER A BLOWN DOWN STUMP.
 FOUND 18 IN. SPLINTERED HEMLOCK STUB WITH VIS-
 IBLE MKS. S B N. 54° W., 13 FT.
 FOUND 12 IN. HEMLOCK, S. 19° W., 7.3 FT. WITH AVISIBLE
 MK. S.
 FOUND 22 IN. HEMLOCK, N. 40° E., 16 1/2 FT. WITH HEALED WIT-
 NESS SCAR.
 FOUND 18 IN. HEMLOCK STUMP, S. 65° E., 17 FT. WITH LOWER
 PART OF WITNESS BLAZE SHOWING.

14. Remarks: SET PIPE UNDER UPROOT.
 New BTs
 28 IN. HEMLOCK N. 75° E., 64 LKS. MKD. T3SR10WS 24BT
 38 IN. FIR, S. 43° 30' W., 68 LKS. MKD. T3SR10WS 26BT
 30 IN. FIR, N. 35° 30' W., 165 LKS. MKD. T3SR10WS 28BT
 NO TREES AVAILABLE IN SECTION 25
