OREGON PUBLIC LAND CORNER REPORT/RESTORATION REPORT
Tillamook County Surveyor's Office

SECTION: 11		TOWNSHIP: 3 NORTH		RANGE: 7 WEST	
COUNTY: TILLAMOOK				DATE: NOVEMBER 05, 2010	
CORNER DESIGNATION: <div style="text-align: center;">

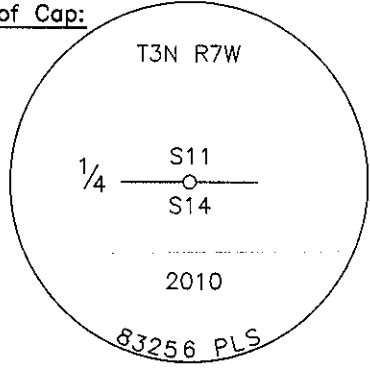
Monument Set (Procedures & Description): FOUND 1 1/2" IRON PIPE RUSTED OFF AT GROUND WITH REMAING 2' OF PIPE LAYING NEXT TO IT. WE SET A NEW 1" IRON PIPE INSIDE OF RUSTED PIPE WITH A 2" BRASS CAP STAMPED AS SHOWN ON DIAGRAM TO RIGHT. ALL REFERENCES WERE THEN CHECKED AND FIT EXISTING CALLS FROM (TILLAMOOK SURVEY RECORD B-2384)				Sketch of Cap: <div style="text-align: center;">
