OREGON PUBLIC LAND CORNER REPORT / RESTORATION REPORT  
Tillamook County Surveyor's Office

<b>SECTION:</b> Southeast corner Section 18	<b>TOWNSHIP:</b> 3 South	<b>RANGE:</b> 7 West
<b>COUNTY:</b> Tillamook		<b>DATE:</b> 08-16-12
The Section corner common to Sections 17, 18, 19 and 20, Township 3 South, Range 7 West; W.M., Tillamook County, Oregon.	(Please check one)	
	<input checked="" type="checkbox"/>	Condition Report Only
	<input type="checkbox"/>	Restoration
	<input type="checkbox"/>	Rewitness
	<input type="checkbox"/>	Unrecorded
	<input type="checkbox"/>	Brass Cap set at surface
<input type="checkbox"/> Referenced Out		
<b>Previous Rewitnesses, Restorations and Surveys, etc:</b> See BLM Field Note Volume OR R0571 Page 513		
<b>Found Monument(s) and Accessories (Condition &amp; Source):</b> Found an iron fence post with a metal location tag North 0.5'. Original GLO bearing trees: An Alder, 15 ins. dia., bears N. 62° E., 73 lks. dist., with no marks remaining on rotted blaze. (Record bearing N. 64 ½° E.). Now- Found a 20" dia. Hollow Alder tree with a hollowed out face. A Fir, 38 ins. diam., bears S. 44° E., 47 lks. dist., with a healed blaze. (Record distance, 57 lks.). Now- F

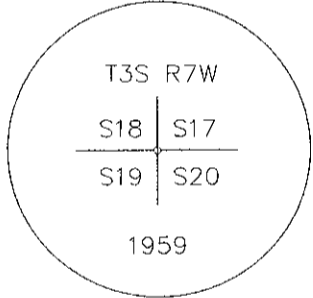
<b>Found Monument Description:</b> Found a 3" diameter U.S. Department of the Interior Bureau of Land Management brass cap upright and in good condition and stamped as shown hereon.	<b>Sketch of Found Monument:</b>
