OREGON PUBLIC LAND CORNER REPORT / RESTORATION REPORT
Tillamook County Surveyor's Office

SECTION: 9 and 10	TOWNSHIP 1 South	RANGE 9 West
COUNTY: Tillamook		DATE: 3-16-12
CORNER DESIGNATION: The Quarter Corner common to Sections 9 and 10, T. 1 S., R. 9 W., W.M.		(Please check one)
		<input type="checkbox"/> Condition Report Only
		<input type="checkbox"/> Restoration
		<input checked="" type="checkbox"/> Rewitness
		<input type="checkbox"/> Unrecorded
		<input type="checkbox"/> Reset at surface
<input type="checkbox"/> Referenced Out		
Previous Rewitnesses, Restorations and Surveys, etc: BLM Field Notes Volume: OR-R0575 Page 227, (1959), same as Rewitness Book 3 Page 149 (1959), Tillamook County Survey Records.		
Found Monument(s) and Accessories (Condition & Source): In 1959, a dependent resurvey of a portion of T. 1 S., R. 9 W., was performed by the Bureau of Land Management where they found no remaining evidence of the original corner or its accessories. They then set a monument at proportionate distance along the section line.

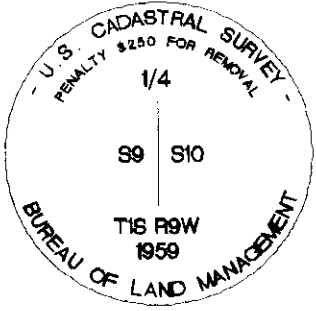
Found 3" dia. B.L.M. Brass Cap, flush, in good condition. The monument is stamped as shown hereon.		
(BLM) – Found 26" Hemlock, was (14"), bears (N 78° W 23 lks. [15.18']), 14.2' to face, healed scar and yellow metal location tag.		
(BLM) – Found 35" Fir, was (28"), bears (S 61° E 114 1/2 lks. [75.57']), 74.0' to face, healed scar.		
() Indicates record information, Tillamook County Survey Records. [] Indicates record links converted to feet.		
Monument Set (Procedures and Description): N/A	Sketch of Found Monument:

New Accessories set: Added a yellow metal location tag to the found BLM BT bearing S 61° E 74.0' to face. Set 120 lbs. of concrete in a 12" dia. cylinder. Set a 72" hat section post with a yellow metal location tag North 3.0' from the monument.		
New Bearing Trees Marked: *20" dia. Spruce bears N 59°30' E 36.5', scribed "T1SR9W1/4S10BT", tagged and painted. *26" dia. Hemlock bears S 26° W 12.5, scribed "T1SR9W1/4S9BT", tagged and painted. * Indicates an aluminum nail with washer marked, "Till. Co. Surveyor" in the face of the blaze between the scribed "B" and "T". Also, a yellow metal location tag affixed in an upper blaze.
