TILLAMOOK COUNTY REWITNESS

SECTION CORNER 31/32
6/5 T 182N R 6 W., WM.

SECTION COR. $\frac{31,32}{615}$ T 142N R 6 W., WM.

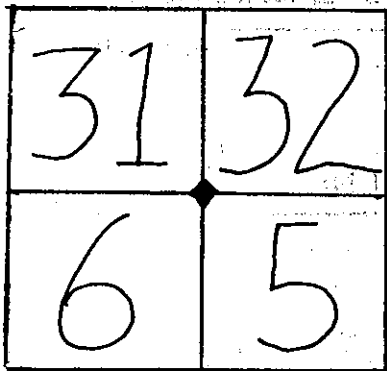
PHOTO#: 241111 (L.S. 793) S. S.

1 SET 1 1/2" IRON PIPE WITH 3" BRASS CAP IN CONCRETE FROM
FOUND 1982 B.T.S SEE PREVIOUS CORNER CARD.
" Hat Section

COMMENTS: 3" (S.H.D.) BRASS CAP
THE CORNER POINT WAS DESTROYED
BY THE STATE HWY. DEPT. DURING HWY SHOULDER WORK.

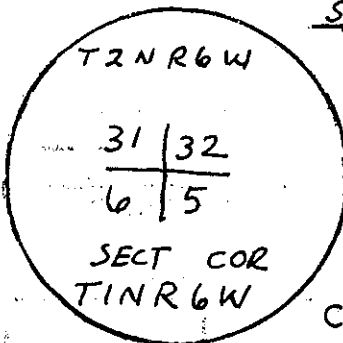
PHOTO#: 250

I FOUND 3" BRASS CAP IN CONCRETE ± 8" DEEP IN THE NORTH
 SHOULDER OF HWY #6. BOOK 1 Pg 168
 " Hat Section

*23" CEDAR	N. 87° E.	192 ⁶⁷	S 32 B.T CS
*10" CEDAR	S. 57° E.	175 ⁸⁹	S 5 B.T CS
*26" FIR	S. 79° W.	247 ⁵⁵	S 6 B.T CS
*24" FIR	N 72° W.	236 ⁰⁵	S 31 B.T CS

DISTANCES TO NAIL WITH CS BRASS WASHER IN FACE.

COMMENTS: THIS CORNER IS LOCATED ON THE
 NLY. SHOULDER OF OREGON STATE HIGHWAY #6 (AKA WILSON RIVER
 HIGHWAY); IN AN AREA WHICH HAS LARGE CUT BANKS ON BOTH
 SIDES OF THE HWY.
