TILLAMOOK COUNTY REWITNESS

INITIAL POINT 29 T 2 N R 10 W., WM. <sup>#91</sup> <sup>also 97</sup>

MANHATTAN

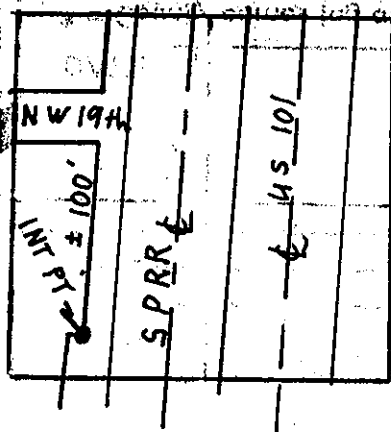
Found, good 1" Dia. IRON PIPE with a WOOD PLUG approx. 8" Below the road surface; WITH A 2" Dia. IRON PIPE (Boiler Tube) with a WOOD PLUG, driven down around the 1" I.P.; WITH A 1" Dia. BRASS DISK welded onto a 1/2" x 3" IRON ROD that was driven into the wood plug in the 2" I.P. The 2" I.P. and Brass Disk are approx. 6" Below the road surface.

There is also concrete around the 2" I.P.

I SET A 3/4" x 15" IRON ROD with a BRASS CAP, inside the FOUND 1" I.P., that is inside the Found 2" I.P., now " Hat Section and I Filled the Hole with Concrete.

COMMENTS: I Set the CS BC flash with the road surface. IT Falls approx. 3 ft West of the East edge of the road, and approx 3.5 ft West of the E of the SPRR.
