TILLAMOOK COUNTY REWITNESS # 107

RANGE COR. LINE 116 SEC. 1217 T 3N R 10 | 9 W., WM.

REWITNESS

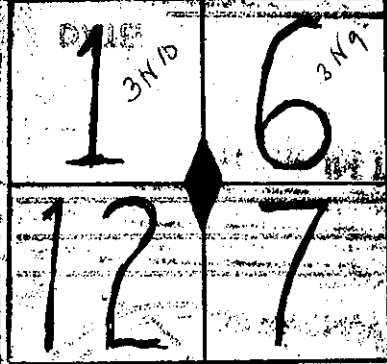
CONDITION GOOD FOUND: 3/4" IRON PIPE Book 1 Page 97

Field 206 ¹⁶	O.K.	NW CORNER CHEESE FACTORY S76°15'E 206 ⁴	Book 1 Page 97
Field 180 ²⁵	O.K.	UPSTREAM SIDE OF BRIDGE LEAD PILE IN END OF CURB ON THE S86°W 181 ¹	Book 1 Page 97
Field 177 ²⁸	O.K.	END OF COPPING TOP OF PIER S79°08'W 177 ²	Book 4 Page 27
Roots IN PLACE		14" ALDER S06°W 438	Book 4 Page 34
GLO WITNESSES GONE - COVERED BY ROAD FILL

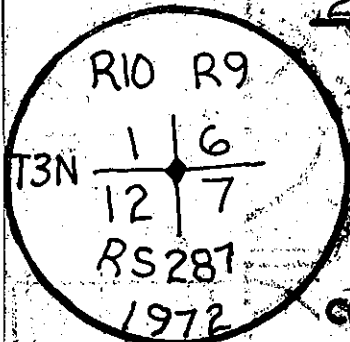
1 SET 1/4" IRON REBAR WITH 3" BRASS CAP IN GALVANIZED TILE AND CONCRETE AT 25' SOUTH OF APPARENT CENTERLINE.

56" NAIL NORTHERLY	100 FEET
56" NAIL WESTERLY	100 FEET

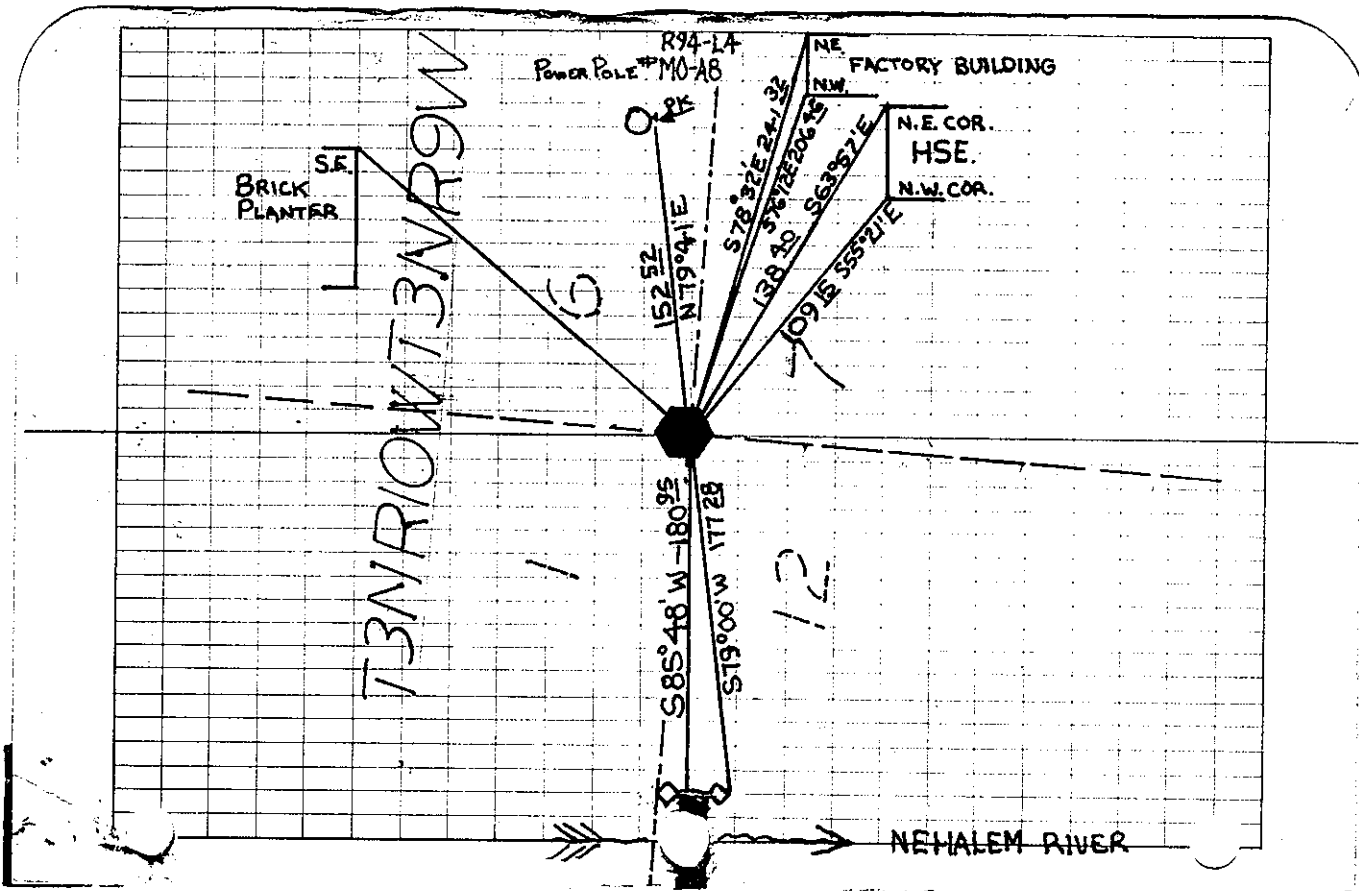
TILLAMOOK COUNTY REWITNESS TITLE

NE COR. HSE. 138.40		NW COR. HSE. 109.15	
B	210°15' RT. INT.	B	218°15' RT. INT.
A		A	
NW COR. CHEESE FACTORY CONTROL 206.46	STOP "S76°12'E"		
B	198°00' RT. INT.		
A			
NE COR. CHEESE FACTORY 241.32	STOP		
B	195°40' RT. INT.		
A			
PILE 152.52	STOP		
B	173°53' RT. INT.		
A			
SE. COR. BRICK PLANTER			
B	130°37' RT. INT.		
A			
END COPPING 177.28	STOP		
119.12			
LEAD PILE N. SIDE BRIDGE = A EAST END	6°48' LT. INT.
