TILLAMOOK COUNTY REWITNESS # 183

N.W. SEC. 7 T. 15 R. 9 W., WM.

TILLAMOOK COUNTY REWITNESS

SEC. COR. <sup>SEC.</sup> 116 T 15 R 9 & 10 W., WM.  
127

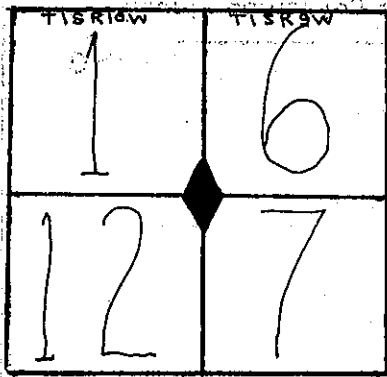
GONE	Spruce 64"	N82°E 71 <sup>28</sup>	GLO TISRLOW Pg 7
GONE	Willow 8"	S61°E 99 <sup>00</sup>	GLO TISRLOW Pg 7
OK	SW Cor. Cheese Factory	N65°48'W 254	BK 4 Pg 43 1946
OK	SE Cor. Cheese Factory	N57°01'E 23E	BK 4 Pg 43 1946
OK	N.W. Cor. School Hse	S30°30'W 237 <sup>3</sup>	BK 4 Pg 43 1946
GONE	MAPLE 4" UNMARKED	S24°E 27 <sup>72</sup>	HAYS BK 'F' Pg 101 1887
POSSIBLY	HATHAWAYS CHIMNEY	S13°W	HAYS BK 'F' Pg 101 1887
COMMENTS: OK	ELLIOTTS Kitchen Chimney	N70°E	HAYS BK 'F' Pg 101 1887
GONE	IRON PIPE IN E Road	South 516	T-26 B 35 & 28

1 SET 3" Brass Cap on 2" Iron Pipe in 90 LBS. Concrete AND Tile feet

BC-A-2-R59	S64°E 27 <sup>98</sup>	S7 BO CS (WITH Finish nail)
BC-A-2-R58	S67°W 47 <sup>29</sup>	S12

COMMENTS: Bk "P9" Pg 97 1925 Anderson & Gulstrom "Fd sec cor" which is a 1/2" Gas Pipe (fourth post from fence corner) Did not find gas pipe when a field search was made.

There is now a bunch of old dryers & washers staked around the corner, THANKS TO REX CAREY'S TV. & appliance. IN THE PRESENCE OF:

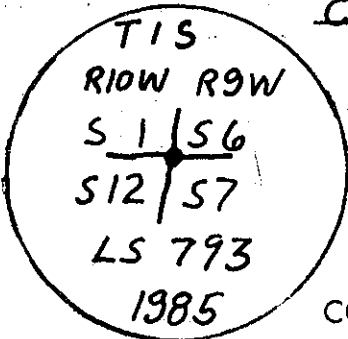
1 SET 1 1/2" IRON PIPE WITH 3" BRASS CAP IN 10" CONCRETE  
CYLINDER

<u>PP# 2-01-10</u>	<u>S 60° W 49 35</u>	<u>Δ (SCRIBED)</u>
<u>PP# 2-01-09</u>	<u>S 54° E 33 15</u>	<u>Δ (SCRIBED)</u>
<u>SW COR STORAGE WAREHOUSE</u>	<u>N 54° W 25 32</u>	<u>NO MARKS</u>
<u>SE " " "</u>	<u>N 56° E 23 61</u>	<u>NO MARKS</u>

STORAGE WAREHOUSE IS OLD CHEESEFACTORY

COMMENTS: THIS CORNER IS LOCATED IN A NEW  
DRIVEWAY TO WAREHOUSE. THE OLD MONUMENT WAS DISTURBED  
BY DRIVEWAY CONSTRUCTION AND DISPLACED ± 0' WEST AND ± 0' 16" NORTH.  
BRASS CAP WAS RIPPED OFF OF OLD MONUMENT ± 15" DEEP IN DRIVEWAY.
