TILLAMOOK COUNTY REWITNESS #249

N.W. 31 SEC. 25 30
COR. 36 31 T / S R 10 & 9 W., WM.
S. E. 25

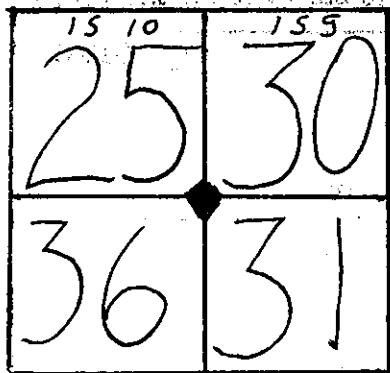
CONDITION GOOD FOUND: LEAD PLUG WITH TACK

FD. GOOD	LEAD PLUG IN CURB	N. 2° E. 58 ⁷ / ₂ FT	BK 4 Pg. 78
NOT FOUND	LEAD PLUG	S. 67° 49' E. 154 ²² / ₂	BK 4 Pg. 78
FD. GOOD	LEAD PLUG	S. 26° E. 105 ²³ / ₂	BK 4 Pg. 78
NOT FOUND	CAP TACK IN P4D P.P.	285 FT	BK 4 Pg. 78

COMMENTS: THIS CORNER IS LOCATED IN THE CENTER OF THE NORTH BOUND LANE OF TILLAMOOK RIVER LOOP ROAD.

1 SET 1/2" IRON ROD WITH 3" BRASS CAP IN CONCRETE
ROAD @ POSITION OF FD. LEAD PLUG WITH TACK
" Hat Section S. E.
