TILLAMOOK COUNTY REWITNESS #333

N.W. 4 SEC. 32/33  
 COR. 5/4 T 1&2S R 10 W., WM.  
 S. E. 32

REWITNESS

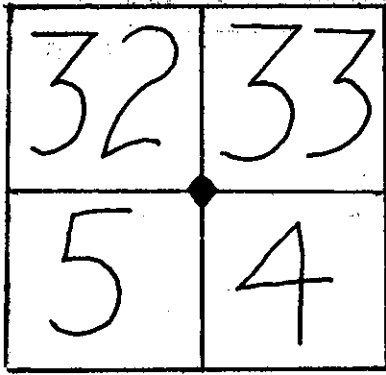
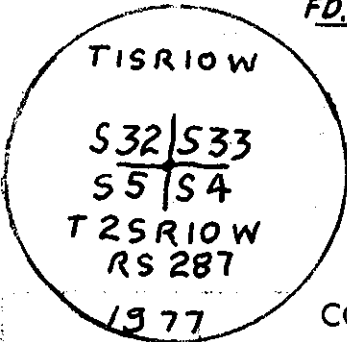
CONDITION GOOD FOUND: 1" IRON PIPE

FD. ROTTEN SNAG	48" SPRUCE	N 60° E	100 LKS	GLO Pg. 8
FD. ROTTEN SNAG	88" SPRUCE	N 55° W	45 LKS	GLO Pg. 8
NOT FD.	56" SPRUCE	S 65° W	43 LKS	GLO Pg. 8
FD. UPROOT	48" SPRUCE	S 30° E	14 LKS	GLO Pg. 8
FD. GOOD NOW 30"	6" SPRUCE	N 66° E	93 FT.	BK 4 Pg. 82
FD. GOOD NOW 30" SCRIBING VISIBLE	6" SPRUCE	SOUTH	60 FT.	BK 4 Pg. 82
FD. GOOD NOW 24"	6" SPRUCE	S 52° W	73 FT.	BK 4 Pg. 82
FD. GOOD. NOW 30"	8" HEMLOCK	N 5° W	200 FT	BK 4 Pg. 82

1 SET 2" IRON PIPE WITH 3" BRASS CAP IN 10" TILE & CEMENT  
 IN POSITION OF FD 1" I.P.  
 FD. 4" x 4" x 60" Post NORTH 13 feet  
 " Hat Section S. E.

COMMENTS: THIS CORNER IS LOCATED ± 400 FT. WEST OF THE END OF A ROCK ROAD MUDDY CAT RD CONTINUES ON AND WINDS UP ± 100 FT. EAST OF THE CORNER CORNER IS ± 100' WEST, MUD CAT ROAD CONTINUES ON NORTHERLY
