TILLAMOOK COUNTY REWITNESS #363
 COR. $\frac{1}{4}$ N. 8. SEC. $\frac{5}{8}$ T 25 R 9 W., WM.

REWITNESS

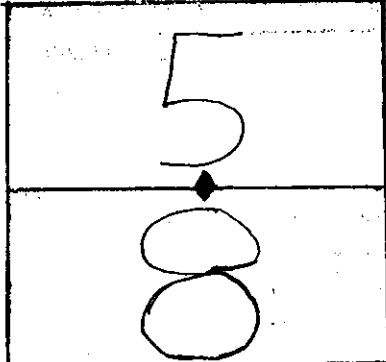
CONDITION Good	FOUND: 1" I.P. IN CONCRETE MAP F-3-10		
GONE	56" SPRUCE	SOUTH 105 LKS	GLO Pg. 25
GONE	64" SPRUCE	N. 58° W. 32 LKS	GLO Pg. 25

1 SET $\frac{5}{8}$ " IRON ROD WITH 3" BRASS CAP INSIDE OF A FOUND 1" IRON PIPE IN A CONCRETE MONUMENT
 60" Hat Section S. ■ 10 FEET

COMMENTS: THIS CORNER IS LOCATED BETWEEN THE RUNWAYS OF TILLAMOOK COUNTY AIRPORT AND ± 800' NLY OF WHERE THE RUNWAYS CROSS. THE DISTANCE TIE ON MAP F-27-7 FITS WITHIN REASON OF A FIELD TIE (± 0.8") BY C.S.!
