TILLAMOOK COUNTY REWITNESS #462

SEC. COR. 17/16  
20/21 T 2 S R 10 W., WM.

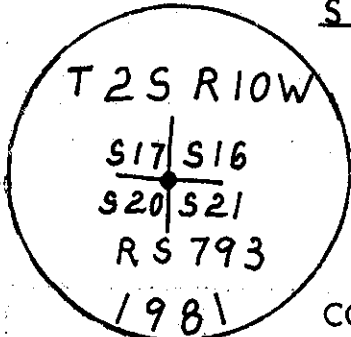
Fd good (GLO)	36" Spruce Stamp, No scribing visible on old face bears S 59° E 194 ft. to face.
Fd good (GLO)	40" Hem. Stamp, No scribing visible on open rotted face bears N 66° E 112 ft. to face.
Fd bad to rusted	1 1/4" Iron Pipe (Map A-782) with a 3/4" I.P. with Brass Cap (Map A-1933). Driven inside of 1 1/4" I.P.

other two GLO trees are gone.

1 SET A 1 1/2" x 30" IRON PIPE WITH A BRASS CAP  
Set in CONCRETE.

\* 60" Hat Section 15 South 4" x 4" white Post 08' W  
NEW ACCESSORY:

* 20" Dia. Hemlock	Bears N 12° W	64.25 ft. to face
Scribed "T 2 S R 10 W S 17 CS BT"

COMMENTS: I removed the Iron Pipes and B.C. and set C.S.B.C. in place of.
