TILLAMOOK COUNTY REWITNESS

#503

W. SEC. $\frac{1}{4}$ COR.

7 T 3 S R 9-10 W., WM.

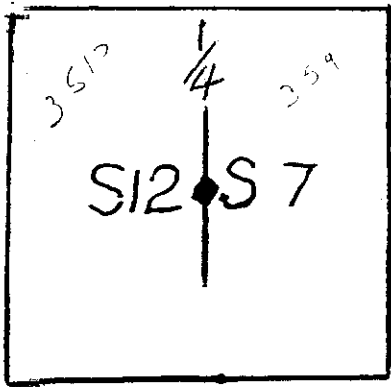
FOUND: OSBF IRON PIPE WITH BRASS CAP

GCNE	2 1/2" ELDER	S52W 100 LKS	GLO PAGE 6
GCNE	3" ELDER	S16E 110 LKS	" " "
GCNE	30" FIR	N17E 83 LKS	
BAD FD	10" SPRUCE	S67W 16 LKS NOW	W23" ROTTED STUMP
BAD FD	16" HEM STUB	4 FEET HIGH	S20E 190
LIVE FD	17" FIR N30W	S35E NOW 24"

LIVE FD 17" HEM S30 1/2 E 129 S
 FD 4X4 W.C. POST - LYING IN CREEK.
 FD 1/4" BOLT 3' LONG - N12W 17

COMMENTS: THIS CORNER IS LOCATED ALONGSIDE OF SMALL CREEK WHERE THE BANK HAS WASH AWAY. BY PERMISSION OF COUNTY SURVEYOR WE BUILT A RETAINING WALL AND RESET CORNER. USED 1/4" BOLT FOR B.O. WHICH IS S81W 8 3/4

1 SET 10" TILE AROUND FD OSBF BRASS CAP AND FILLED WITH CONCRETE
