Index File No. <u>65</u>	CORNER RECORD (SEARCH) (Ref. FSM 7151.4)		Tract or Survey No. _____	Cor. No. _____
T. <u>5S</u> R. <u>10W</u>	R.D. <u>HEBO</u>	County <u>TILLA</u>	# <u>903</u>	
Merid. <u>WILL.</u>	N.F. <u>SIUSLAW</u>	State <u>ORE.</u>		
CORNER DIAGRAM

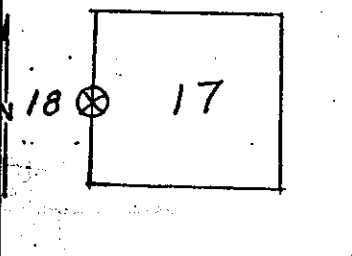
DESCRIBE CORNER MONUMENT FOUND <u>GLO 1872 SET POST & MARKED</u> <u>16" SPRUCE, N. 10° W., 42 LKS.</u> <u>6" ALDER, S. 30° E., 25 LKS.</u>			
	DESCRIBE BEARING TREES OR OTHER OFFICIAL ACCESSORIES FOUND <u>FOUND 48X5X5 POST IN POOR CONDITION SCRIBED</u> <u>"1/4 S ON S., # 287 ON N. SIDES."</u> <u>A TIN IS ATTACHED TO TOP OF POST MARKED "1/4</u> <u>CORNER 18/17 SET BY PROPORTIONMENT N-S TRANSIT &</u> <u>CHAIN J. L. CARLICH # 287 BELL 4-57.</u>			
PHOTO IDENTIFICATION DATA Photo No. <u>ETJ-5-152</u> Filed At. _____ Object Ident. <u>DIRECT</u> Ident. By <u>L. Whitmore</u> <i>Signature</i>	DESCRIBE CORNER LOCATION RELATIVE TO NEAR-BY FEATURES, ALSO HOW TO REACH CORNER <u>OLD LOGGING IS ON WEST SIDE AND MUCH BLOWDOWN</u> <u>ON EAST SIDE.</u> <u>I CANNOT FIND ANY IDENTIFIABLE REFERENCES.</u> <u>ON A STEEP NORTH SLOPE.</u>
