TILLAMOOK COUNTY REWITNESS # 1036

1/4 COR. SEC. 35 / 2 T 1 & 2 N R 10 W., WM.

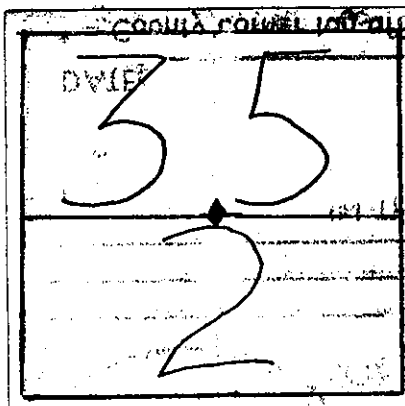
CONDITION GOOD FOUND: 1/2" IRON PIPE WITH 3" BRASS CAP BK 2 Pg. 466

* GOOD, NOW 34" FACE OVERGROWN	11" SPRUCE	N. 80° W. 39 3/4'	BK 2 Pg. 466
* GOOD, NOW 14" FACE OVERGROWN	5" SPRUCE	S. 65° E. 173'	BK 2 Pg. 466

I SET 10" CONCRETE CYLINDER AROUND FOUND O.S.B.F. 1/2" IRON PIPE WITH 3" BRONZE CAP 1 1/4" DEEP IN PASTURE BK 2 Pg. 466

COMMENTS: THIS CORNER IS LOCATED IN WALDRON'S PASTURE ON THE EAST SIDE OF THE MIAMI RIVER NEAR THE NORTH EDGE OF THE PASTURE.

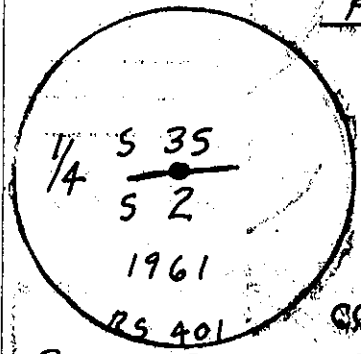
* 72" Half Section WEST 47 1/2 FEET
